**Flood Control Project Maintenance
Levee Inspections**

Maintenance Issue Types Only, Levee Inspection Report By Mile - Spring 2017

Reclamation District No. 2031 Elliot

Waterway	Bank	Unit Miles	Inspection Start/End	Inspector
Unit No. 01 Stanislaus River	Left	7.07	04/25/2017 04/25/2017	Maksim Khashchuk

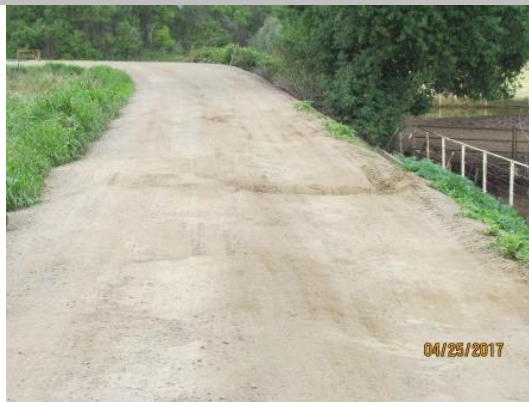
Photo 1 of 1 : SP_2017_RD2031_307_18_20170427_00110.jpg

LM Start	0.03	Rating **	M	Issue No.	18
LM End	0.03	Issue Type +	Ma	Location *	CR
Category	Earthen Levee			GPS Latitude/Longitude	
				Start	End
Item	Crown Surface / Depressions / Rutting			37.709989 °	37.709989 °
				-121.155892 °	-121.155892 °
DWR ID	DWR_RD2031_01_s_2017_18				
Comment Code					
C2 : Repair depressions or ruts in the crown or slope.					
Inspector Comment					
Add appropriate fill to pot hole to bring levee crown back to grade.

View of the potholes on the levee crown.

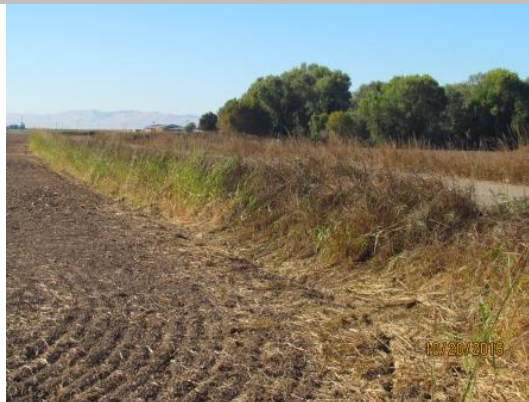
Photo 1 of 1 : SP_2017_RD2031_307_31_20170407_00017.jpg

LM Start	0.07	Rating **	M	Issue No.	31
LM End	0.15	Issue Type +	Ma	Location *	LS
Category	Earthen Levee			GPS Latitude/Longitude	
				Start	End
Item	Vegetation			37.709915 °	37.708707 °
				-121.156548 °	-121.156764 °
DWR ID	DWR_RD2031_01_f_2016_31				
Comment Code					
V1 : Control annual grass and weeds on the levee slopes and easements.					
Inspector Comment

View of the vegetation on the landside levee slope.

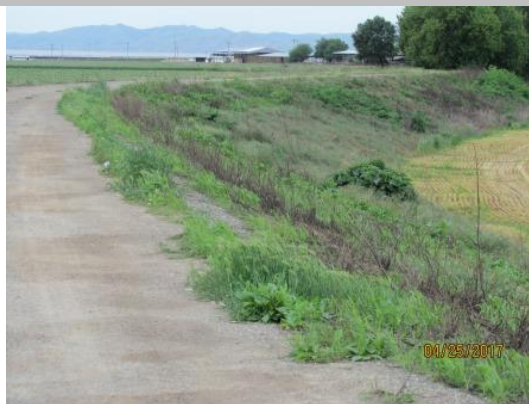
Photo 1 of 1 : SP_2017_RD2031_307_32_20170427_00111.jpg

View of the vegetation on the waterside levee slope. Looking downstream.

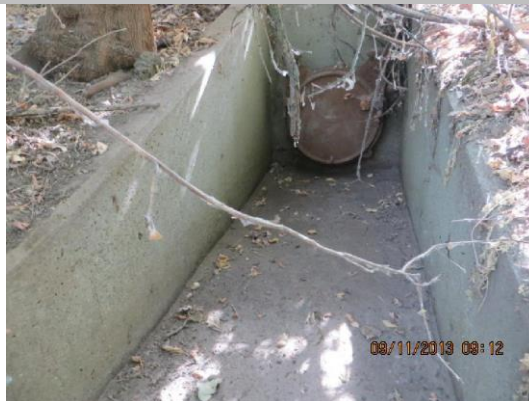
Photo 2 of 2 : UCIP_SP_2017_20024_33923.jpg

Concrete headwall and flapgate on WS toe.

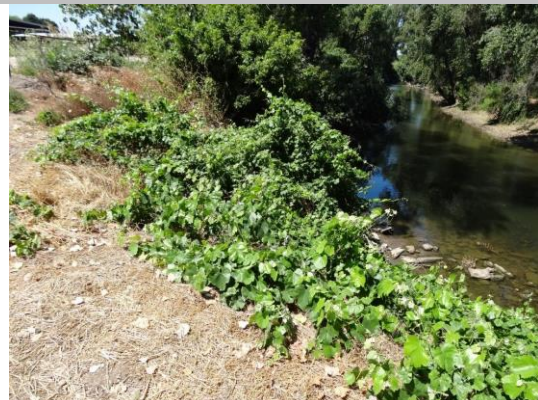
Photo 2 of 2 : SP_2017_RD2031_307_1_20170407_00002.jpg

View of the current condition of the bank slope just above the irrigation outlet.

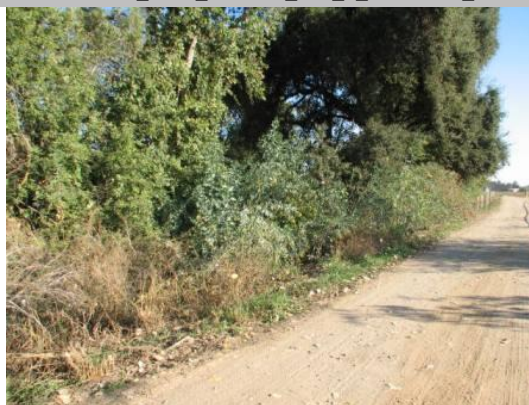
Photo 3 of 3 : SP_2017_RD2031_307_2_20170407_00005.jpg

10/26/2011 Updated photo of waterside vegetation.

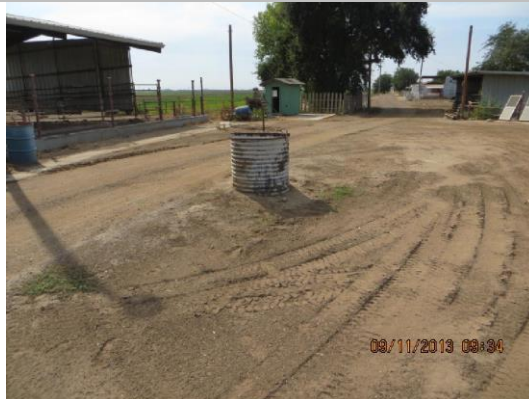
Photo 1 of 3 : UCIP_SP_2017_20044_33942.jpg

LM Start	0.56	Rating **	A/W	Issue No.	984
LM End	0.56	Issue Type +	Ma	Location *	WS
Category	Supplemental			GPS Latitude/Longitude	
				Start	End
Item	DWR UCIP LMA Responsibility			37.703323 °	37.703323 °
				-121.159771 °	-121.159771 °
DWR ID					
Comment Code					
Inspector Comment					
FS_ID:20044 DS_ID:20439 EP_NO: N/A Repair Type: No Action Needed Crossing Status: Found UCIP Comments: FIELD_STRUCT_DESC: 15-inch corrugated metal pipe stormdrain through the levee 9.0-feet below the crown. Slide gate in 36-inch corrugated metal pipe riser on the waterward slope. Drainage canal off LS toe. Originally included in the 1968 O&M manual. This pipe replaced a 15-inch pipe at same location. FS Date: 9/11/2013

36-inch CMP riser on WS shoulder.

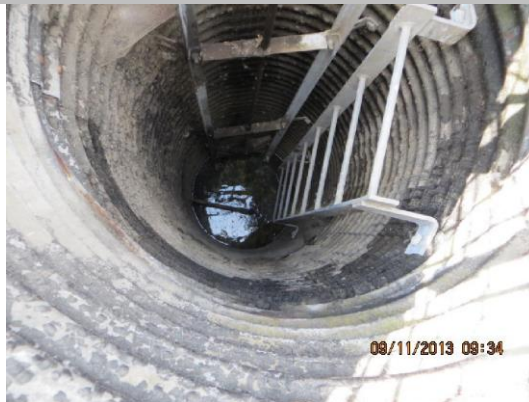
Photo 2 of 3 : UCIP_SP_2017_20044_33941.jpg

Slide gate in CMP riser on WS shoulder.

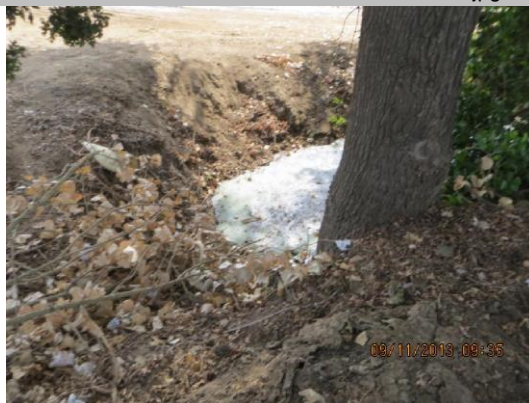
Photo 3 of 3 : UCIP_SP_2017_20044_33940.jpg

Drainage ditch at inlet on LS toe.

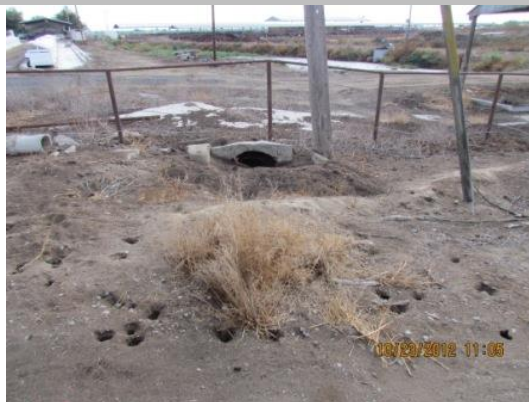
Photo 1 of 1 : SP_2017_RD2031_307_36_20170407_00023.jpg

LM Start	0.77	Rating **	M	Issue No.	36
LM End	0.77	Issue Type +	Ma	Location *	LS
Category	Earthen Levee			GPS Latitude/Longitude	
				Start	End
Item	Animal Control			37.701177 °	37.701177 °
				-121.162055 °	-121.162055 °
DWR ID	DWR_RD2031_01_f_2012_36				
Comment Code					
A3 : No rodents visible, but rodent burrows visible; need to backfill and compact or grout burrows.					
Inspector Comment

View of rodent burrows on landside slope.

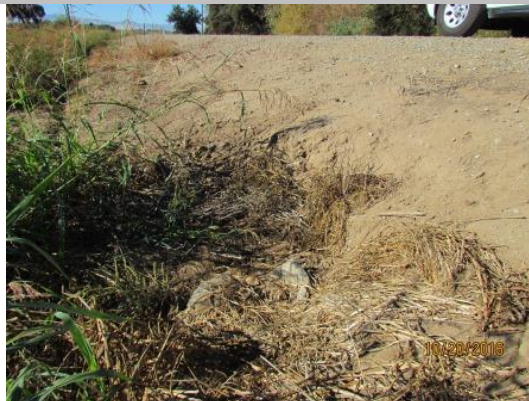
Photo 1 of 1 : SP_2017_RD2031_307_42_20170407_00027.jpg

LM Start	0.84	Rating **	M	Issue No.	42
LM End	0.84	Issue Type +	Ma	Location *	LS
Category	Earthen Levee			GPS Latitude/Longitude	
				Start	End
Item	Erosion / Bank Caving			37.700447 °	37.700447 °
				-121.162742 °	-121.162742 °
DWR ID	DWR_RD2031_01_f_2016_42				
Comment Code					
E2 : Schedule repair of erosion site prior to the next inspection.					
Inspector Comment

View of the erosion of the landside levee slope.

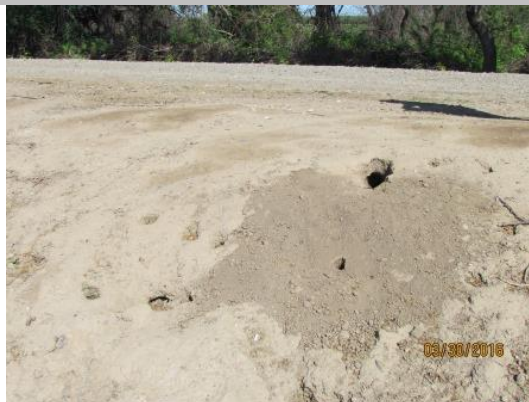
Photo 2 of 3 : SP_2017_RD2031_307_59_20170407_00043.jpg

LM Start	1.00	Rating **	M	Issue No.	59
LM End	1.00	Issue Type +	Ma	Location *	LS
Category	Earthen Levee			GPS Latitude/Longitude	
				Start	End
Item	Animal Control			37.699327 °	37.699327 °
				-121.165364 °	-121.165364 °
DWR ID	DWR_RD2031_01_f_2014_59				
Comment Code					
A3 : No rodents visible, but rodent burrows visible; need to backfill and compact or grout burrows.					
Inspector Comment					
Some of the rodent holes have collapsed.

Another view of the rodent hole on the landside levee slope.

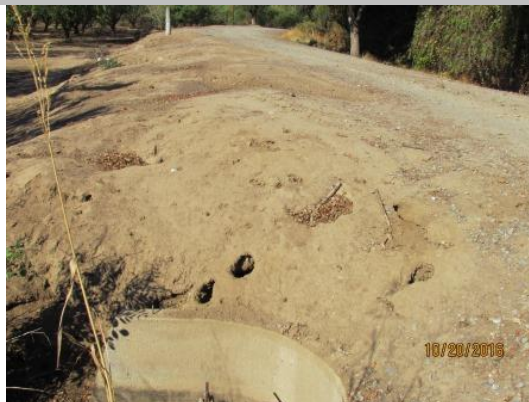
Photo 2 of 2 : SP_2017_RD2031_307_44_20170407_00029.jpg

Another view of the rodent holes on the landside levee slope.

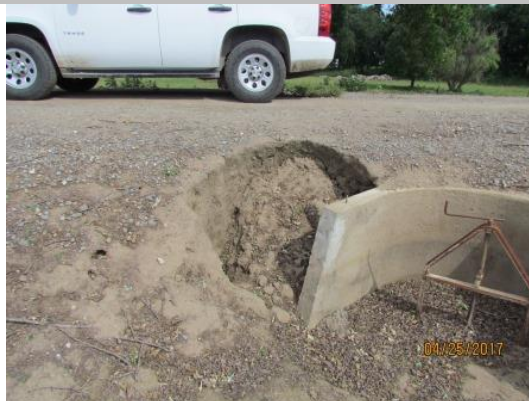
Photo 1 of 1 : SP_2017_RD2031_307_62_20170427_00113.jpg

LM Start	1.41	Rating **	U	Issue No.	62
LM End	1.41	Issue Type +	Ma	Location *	LS
Category	Earthen Levee			GPS Latitude/Longitude	
				Start	End
Item	Erosion / Bank Caving			37.699833 °	37.699833 °
				-121.172060 °	-121.172060 °
DWR ID	DWR_RD2031_01_s_2017_62				
Comment Code					
E2 : Schedule repair of erosion site prior to the next inspection.					
Inspector Comment

View of the erosion on the levee slope penetrating levee prism.

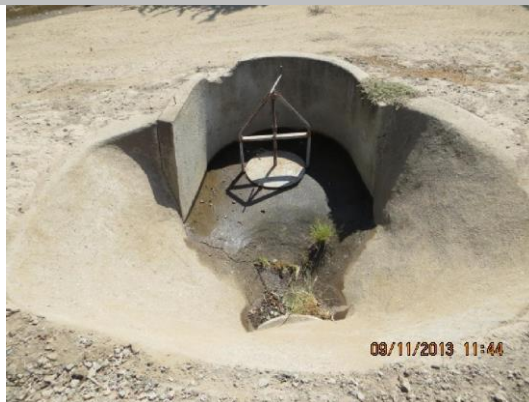
Photo 1 of 3 : UCIP_SP_2017_20088_34030.jpg

LM Start	1.55	Rating **	A/W	Issue No.	990
LM End	1.55	Issue Type +	Ma	Location *	LS
Category	Supplemental			GPS Latitude/Longitude	
				Start	End
Item	DWR UCIP LMA Responsibility			37.698921 °	37.698921 °
				-121.174144 °	-121.174144 °
DWR ID					
Comment Code					
Inspector Comment					
FS_ID:20088 DS_ID:20446 EP_NO: N/A Repair Type: No Action Needed Crossing Status: Found UCIP Comments: FIELD_STRUCT_DESC: 24-inch corrugated metal pipe through the levee 3.5-feet below the crown. Concrete headwalls on both ends. Flap gate on the waterward end. Installed by USACE, 1966. Also included in the 1968 O&M manual. FS Date: 9/11/2013

Bowl shaped concrete inlet on LS slope.

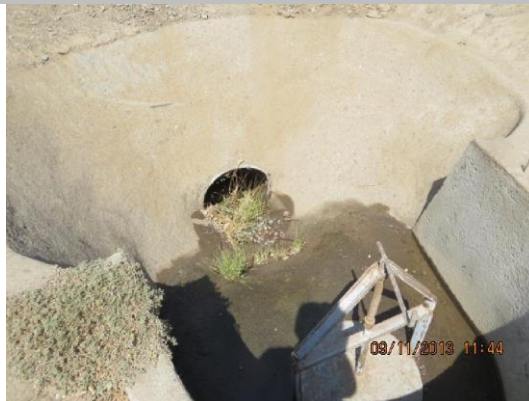
Photo 2 of 3 : UCIP_SP_2017_20088_34029.jpg

Bowl shaped concrete inlet on LS slope.

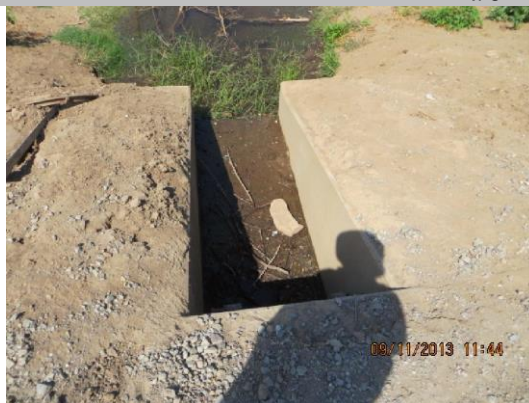
Photo 3 of 3 : UCIP_SP_2017_20088_34028.jpg

Concrete U-shaped headwall on WS slope.

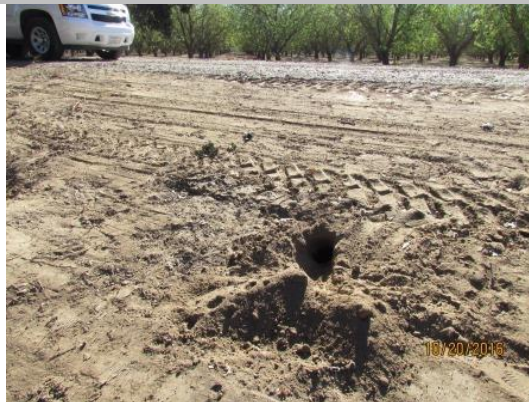
Photo 1 of 1 : SP_2017_RD2031_307_52_20170407_00036.jpg

View of the active rodent hole on the levee slope. Fall 2016

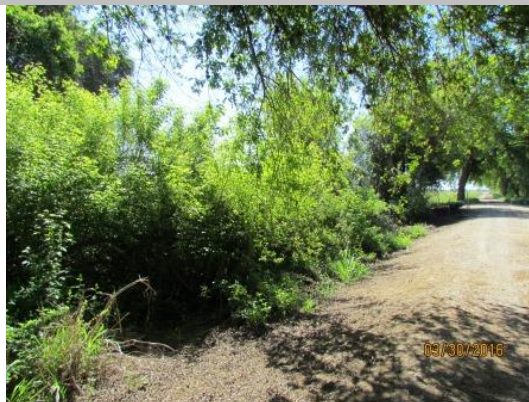
Photo 2 of 2 : SP_2017_RD2031_307_29_20170407_00016.jpg

Another view of the tall vegetation on the landside levee slope.

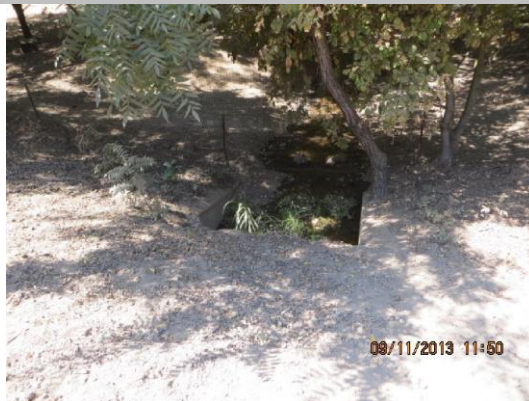
Photo 1 of 3 : UCIP_SP_2017_41354_34034.jpg

LM Start	1.78	Rating **	M	Issue No.	991
LM End	1.78	Issue Type +	Ma	Location *	LS
Category	Supplemental			GPS Latitude/Longitude	
				Start	End
Item	DWR UCIP LMA Responsibility			37.696958 °	37.696958 °
				-121.177464 °	-121.177464 °
DWR ID					
Comment Code					
Inspector Comment					
FS_ID:41354 DS_ID:20470 EP_NO: N/A Repair Type: Non-Urgent Crossing Status: Found UCIP Comments: Silt buildup at inlet and outlet. FIELD_STRUCT_DESC: 1 of 2: 24-inch corrugated metal pipe through the levee 9.5-feet below the crown. Concrete "U"-shaped headwalls on both ends. Flap gate on the waterward end. Installed by USACE, 1966. Also included in the 1968 O&M manual. FS Date: 9/11/2013

Concrete headwall on WS toe.

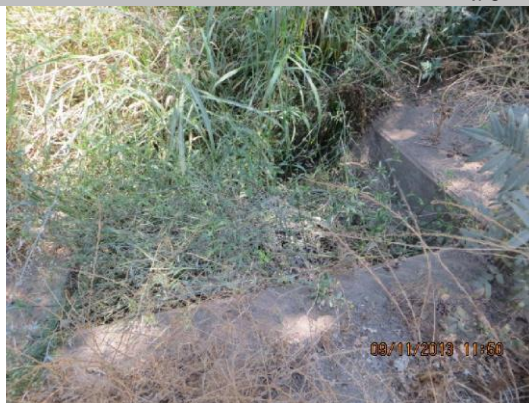
Photo 2 of 3 : UCIP_SP_2017_41354_34033.jpg

Concrete headwall on LS toe.

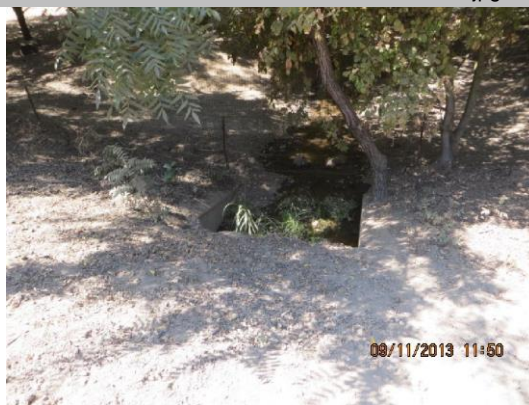
Photo 1 of 3 : UCIP_SP_2017_20092_34041.jpg

LM Start	1.78	Rating **	M	Issue No.	992
LM End	1.78	Issue Type +	Ma	Location *	LS
Category	Supplemental			GPS Latitude/Longitude	
				Start	End
Item	DWR UCIP LMA Responsibility			37.696943 °	37.696943 °
				-121.177470 °	-121.177470 °
DWR ID					
Comment Code					
Inspector Comment					
FS_ID:20092					
DS_ID:20447					
EP_NO: N/A					
Repair Type: Non-Urgent					
Crossing Status: Found					
UCIP Comments: Silt buildup at inlet and outlet.					
FIELD_STRUCT_DESC: 2 of 2: 24-inch corrugated metal pipe through the levee 9.5-feet below the crown. Concrete "U"-shaped headwalls on both ends. Flap gate on the waterward end. Installed by USACE, 1966. Also included in the 1968 O&M manual.					
FS Date: 9/11/2013

Concrete U-shaped headwall on WS toe.

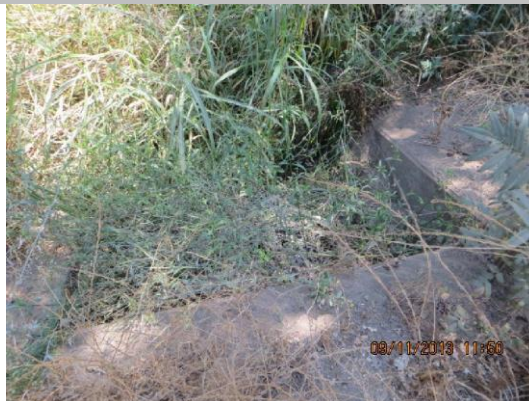
Photo 2 of 3 : UCIP_SP_2017_20092_34040.jpg

Concrete U-shaped headwall on LS toe.

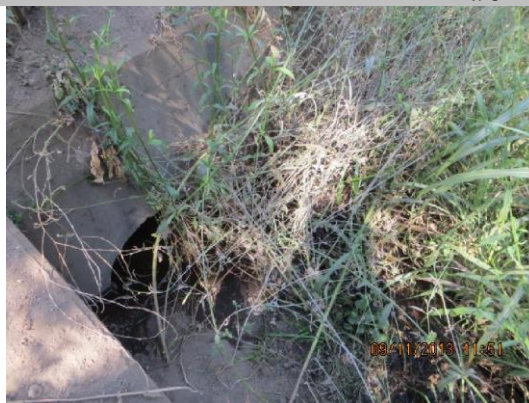
Photo 3 of 3 : UCIP_SP_2017_20092_34039.jpg

Concrete U-shaped headwall on LS toe.

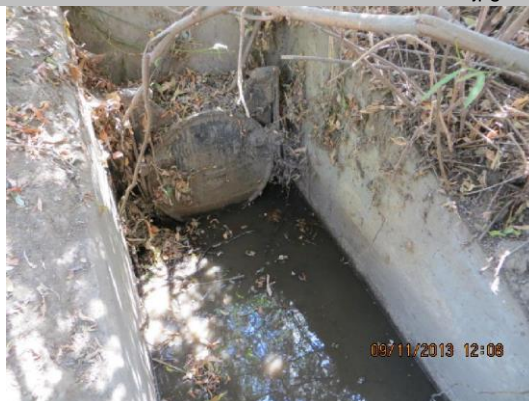
Photo 1 of 3 : UCIP_SP_2017_20110_34078.jpg

LM Start	2.39	Rating **	A/W	Issue No.	994
LM End	2.39	Issue Type +	Ma	Location *	CR
Category	Supplemental			GPS Latitude/Longitude	
				Start	End
Item	DWR UCIP LMA Responsibility			37.688676 °	37.688676 °
				-121.179622 °	-121.179622 °
DWR ID					
Comment Code					
Inspector Comment					
FS_ID:20110					
DS_ID:20449					
EP_NO: N/A					
Repair Type: No Action Needed					
Crossing Status: Found					
UCIP Comments:					
FIELD_STRUCT_DESC: 24-inch corrugated metal drainpipe through levee 3.0 feet below crown. Concrete "U" headwall on the waterward end. Flap gate an the waterward end. 5'X5' concrete riser with pump on LS toe. Likely that concrete riser is inlet for drainpipe. Originally included in 1968 O&M manual.					
FS Date: 9/11/2013

Flapgate and concrete headwall on WS toe.

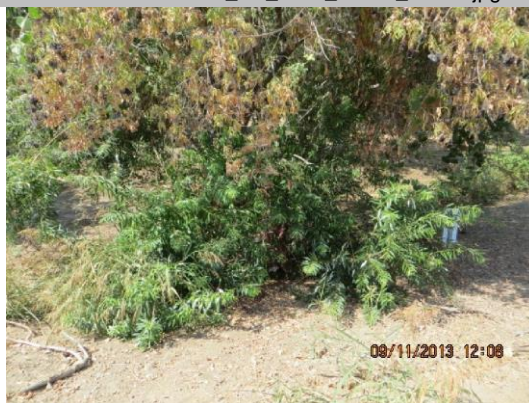
Photo 2 of 3 : UCIP_SP_2017_20110_34077.jpg

Vegetation covers outlet of pipe on WS slope.

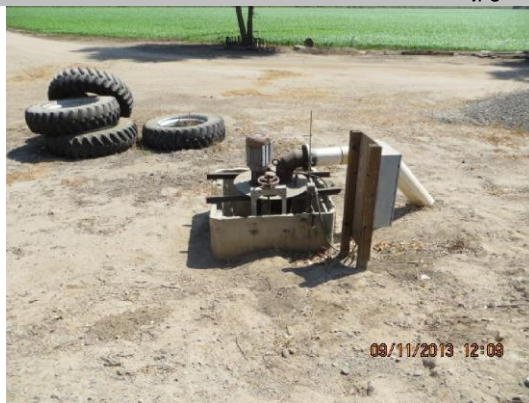
Photo 3 of 3 : UCIP_SP_2017_20110_34076.jpg

5'X5' concrete riser with pump on LS toe.

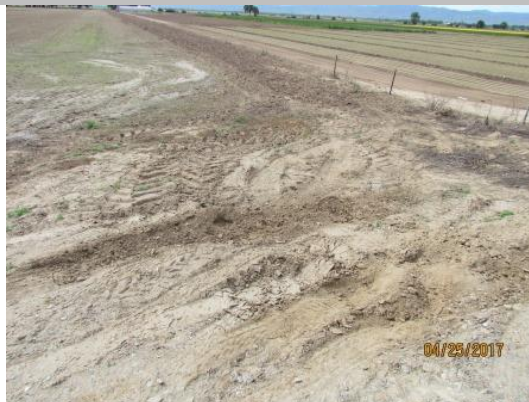
Photo 1 of 1 : SP_2017_RD2031_307_67_20170427_00118.jpg

LM Start	2.82	Rating **	M	Issue No.	67
LM End	2.82	Issue Type +	Ma	Location *	LS
Category	Earthen Levee			GPS Latitude/Longitude	
				Start	End
Item	Slope Stability			37.686751 °	37.686751 °
				-121.186743 °	-121.186743 °
DWR ID	DWR_RD2031_01_s_2017_67				
Comment Code					
S3 : Repair the levee slope damaged by vehicle traffic and prevent access where possible.					
Inspector Comment

View of the tire ruts on the levee slope.

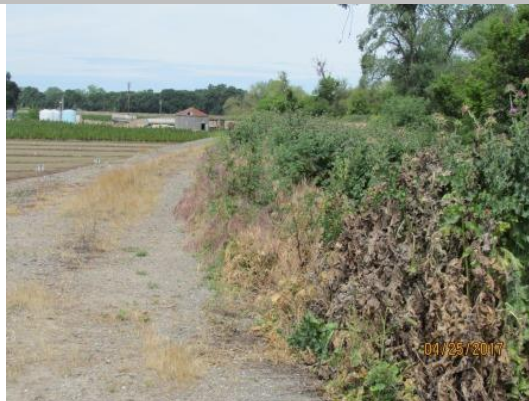
Photo 1 of 1 : SP_2017_RD2031_307_68_20170427_00119.jpg

View of the tall vegetation on the levee slope.

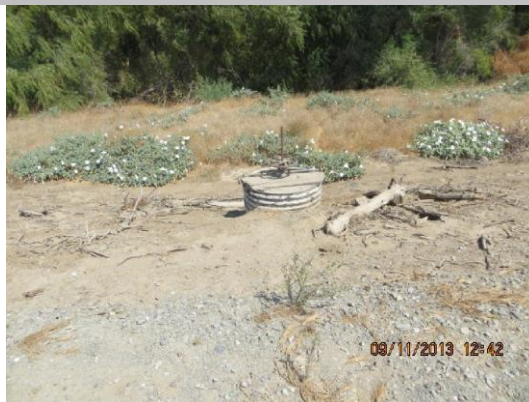
Photo 1 of 3 : UCIP_SP_2017_20449_34506.jpg

LM Start	3.08	Rating **	M	Issue No.	996
LM End	3.08	Issue Type +	Ma	Location *	WS
Category	Supplemental			GPS Latitude/Longitude	
				Start	End
Item	DWR UCIP LMA Responsibility			37.688297 °	37.688297 °
				-121.190865 °	-121.190865 °
DWR ID					
Comment Code					
Inspector Comment					
FS_ID:20449 DS_ID:20451 EP_NO: N/A Repair Type: Non-Urgent Crossing Status: Found UCIP Comments: Pipe appears to be abandoned and if so should be done so properly. FIELD_STRUCT_DESC: *ABANDONED* 24-inch corrugated metal pipe through levee 14.0 feet below crown. Slide gate in 36-inch corrugated metal pipe riser on the waterward slope. Originally included in the 1968 O&M manual. FS Date: 9/11/2013

Slide gate in CMP riser on WS slope.

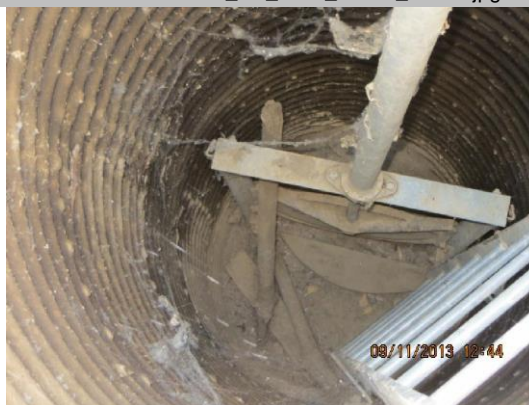
Photo 3 of 3 : UCIP_SP_2017_20449_34504.jpg

Slide gate in CMP riser on WS slope.

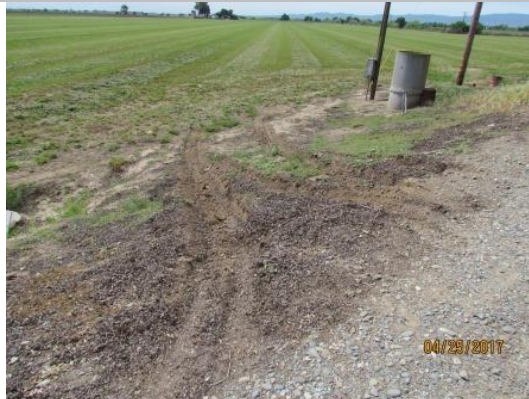
Photo 1 of 1 : SP_2017_RD2031_307_69_20170427_00121.jpg

LM Start	3.59	Rating **	M	Issue No.	69
LM End	3.59	Issue Type +	Ma	Location *	LS
Category	Earthen Levee			GPS Latitude/Longitude	
				Start	End
Item	Slope Stability			37.690409 °	37.690409 °
				-121.197291 °	-121.197291 °
DWR ID	DWR_RD2031_01_s_2017_69				
Comment Code					
S3 : Repair the levee slope damaged by vehicle traffic and prevent access where possible.					
Inspector Comment

View of the tire ruts on the levee slope.

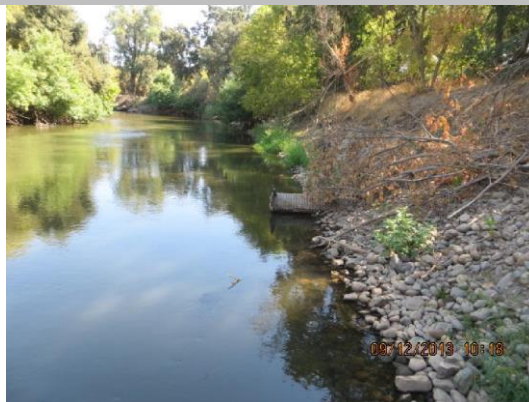
Photo 1 of 2 : UCIP_SP_2017_23064_39200.jpg

CMP pipe and flapgate visible at WS toe.

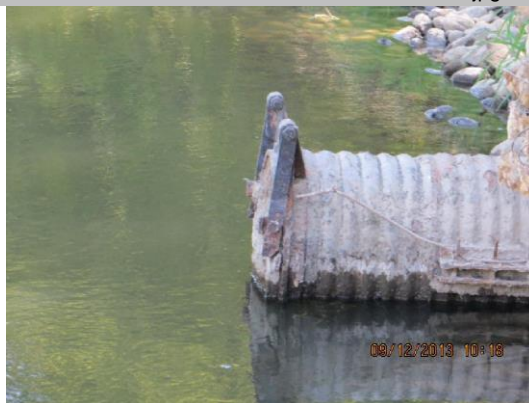
Photo 2 of 2 : UCIP_SP_2017_23064_39199.jpg

CMP pipe and flapgate visible at WS toe.

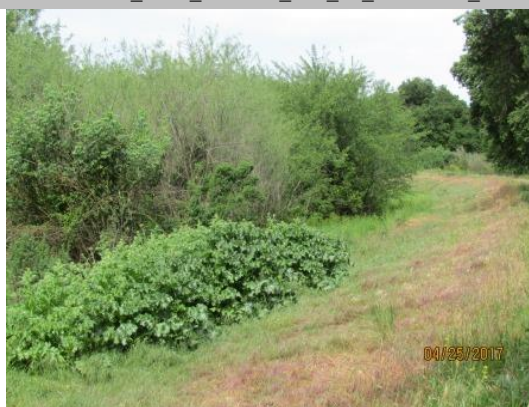
Photo 1 of 4 : SP_2017_RD2031_307_33_20170427_00122.jpg

View of the vegetation at the levee toe and slope.

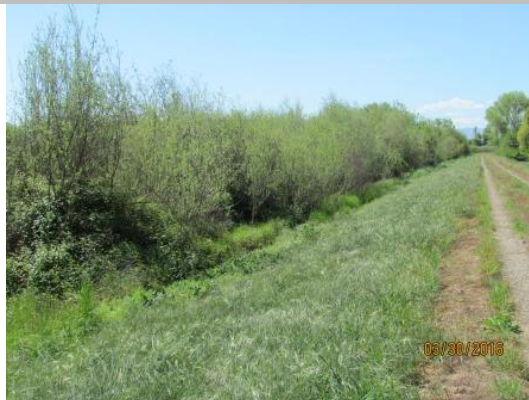
Photo 4 of 4 : SP_2017_RD2031_307_33_20170407_00021.jpg

Another view of the tall vegetation on the landside levee slope and toe.

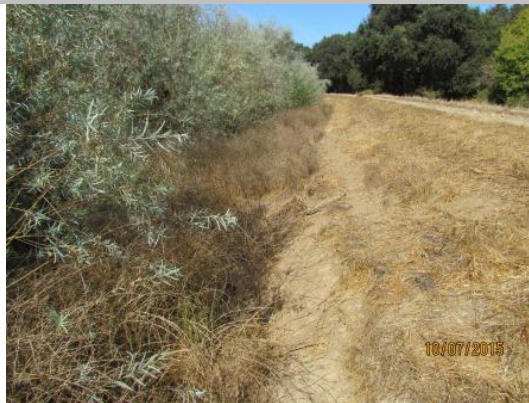
Photo 1 of 1 : SP_2017_RD2031_307_57_20170407_00040.jpg

View of the 18 inch vertical cut at the landside levee toe.

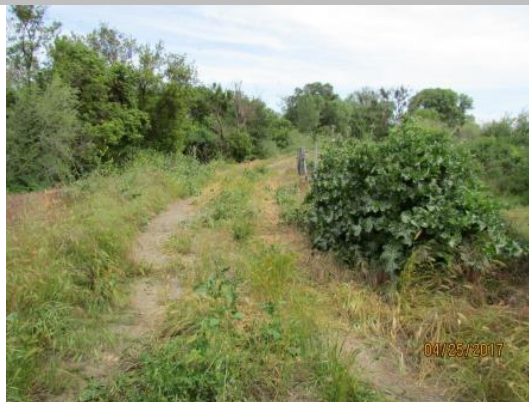
Photo 1 of 1 : SP_2017_RD2031_307_70_20170427_00123.jpg

View of the tall vegetation on the levee crown and slope.

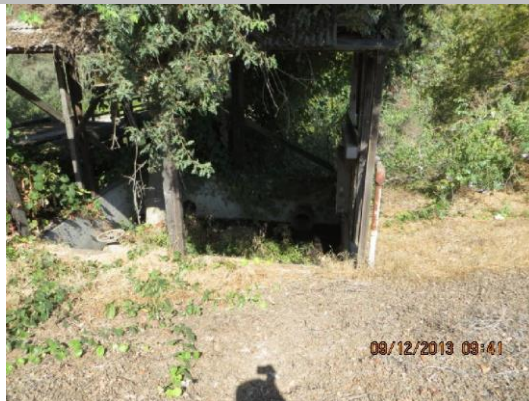
Photo 1 of 3 : UCIP_SP_2017_20683_34782.jpg

Pipe visible inside pumphouse on WS slope.

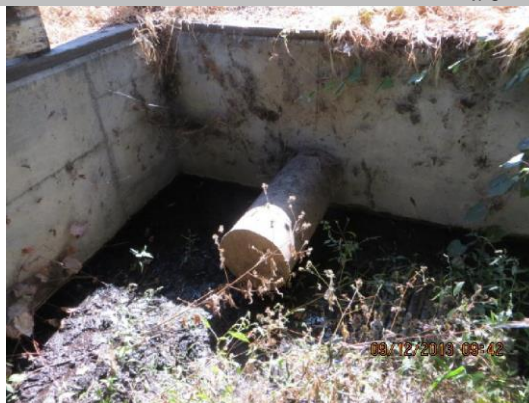
Photo 2 of 3 : UCIP_SP_2017_20683_34781.jpg

Welded steel plate over WS end of pipe.

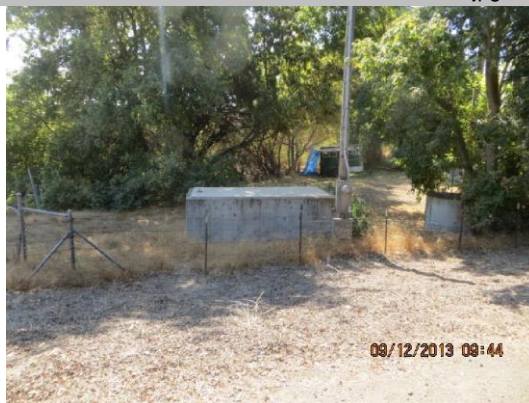
Photo 3 of 3 : UCIP_SP_2017_20683_34780.jpg

Concrete distribution box on LS toe.

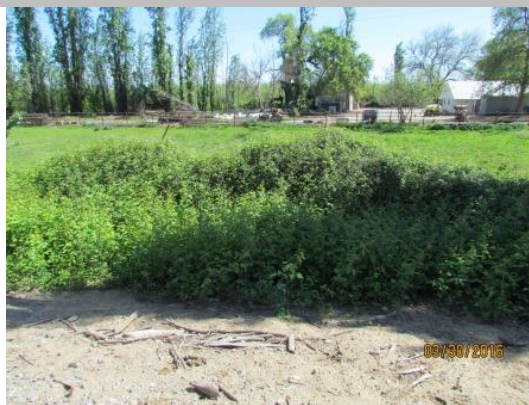
Photo 1 of 1 : SP_2017_RD2031_307_43_20170407_00028.jpg

View of the tall vegetation on the landside levee slope and toe.

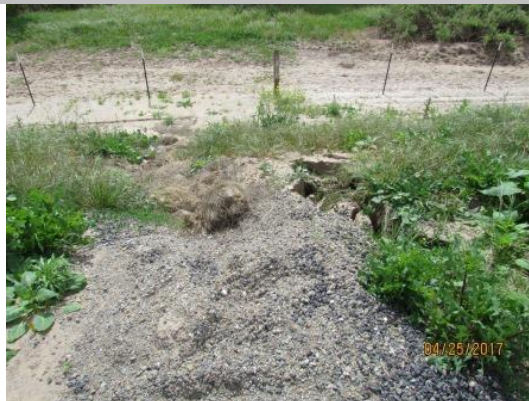
Photo 1 of 1 : SP_2017_RD2031_307_71_20170427_00124.jpg

View of the erosion on the levee slope.

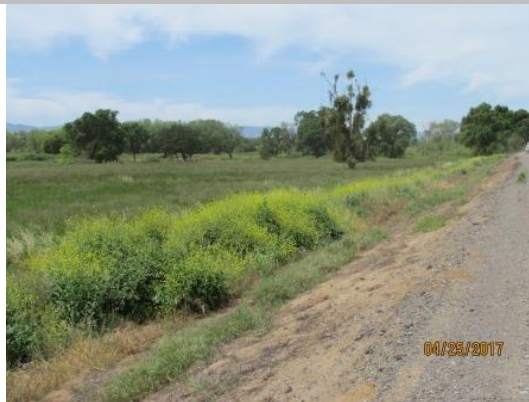
Photo 1 of 1 : SP_2017_RD2031_307_73_20170427_00126.jpg

View of the vegetation on the levee slope.

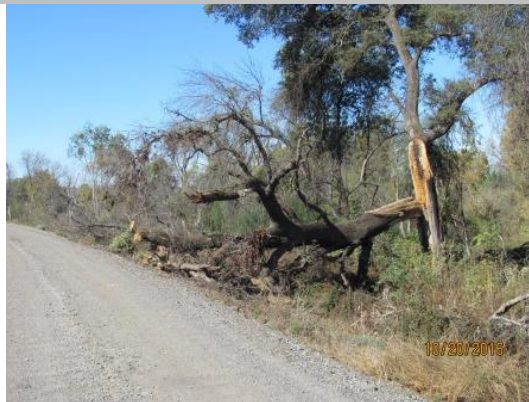
Photo 1 of 1 : SP_2017_RD2031_307_56_20170407_00039.jpg

View of the broken tree limb on the levee slope.

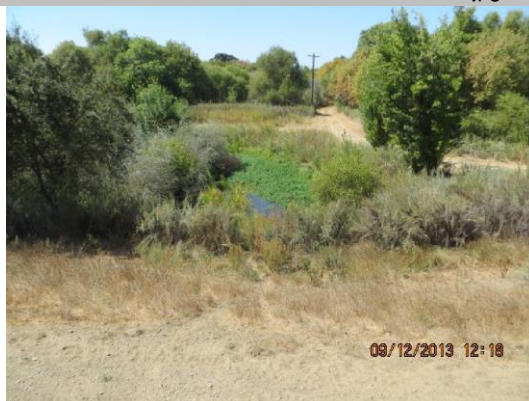
Photo 2 of 3 : UCIP_SP_2017_20703_34821.jpg

Pond at outlet on WS toe.

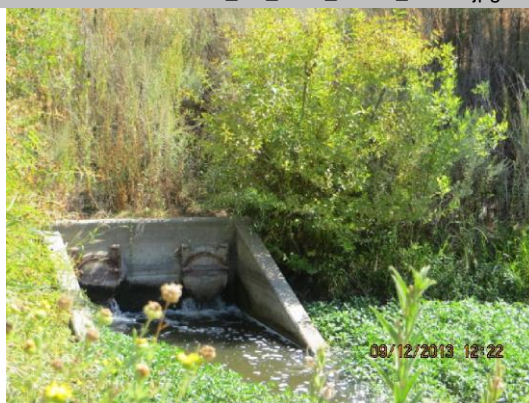
Photo 3 of 3 : UCIP_SP_2017_20703_34820.jpg

Concrete U-shaped headwall with flapgate on WS toe.

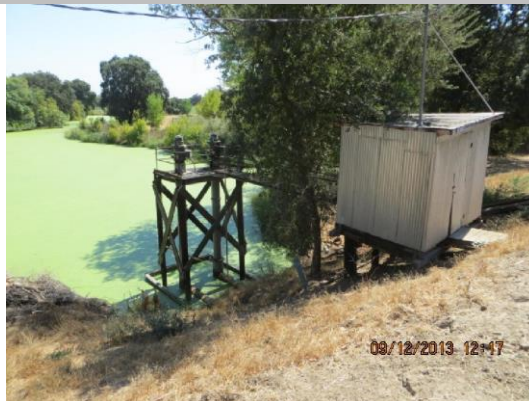
Photo 1 of 3 : UCIP_SP_2017_20704_34826.jpg

Pump on pier on LS toe with shed at pump walkway.

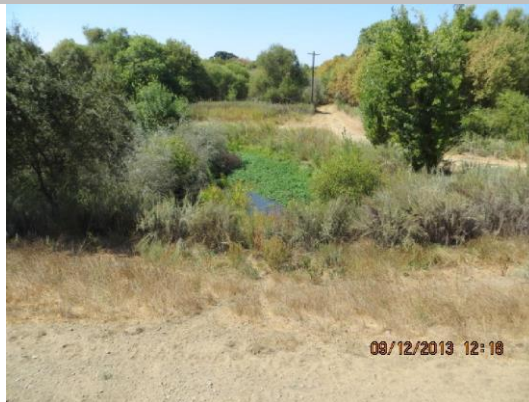
Photo 2 of 3 : UCIP_SP_2017_20704_34825.jpg

Pond at outlet on WS toe.

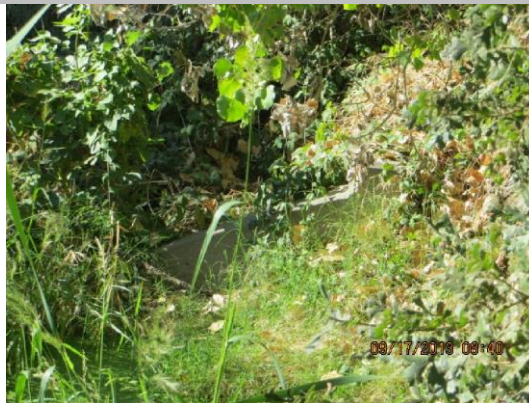
Photo 2 of 3 : UCIP_SP_2017_20708_34833.jpg

Concrete headwall on LS toe at edge of pond.

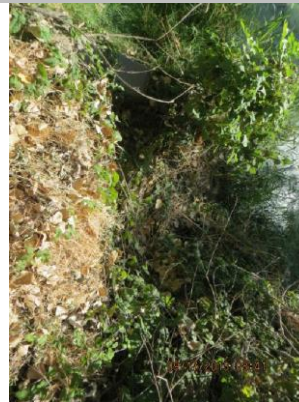
Photo 3 of 3 : UCIP_SP_2017_20708_34832.jpg

Concrete headwall on LS toe at edge of pond.

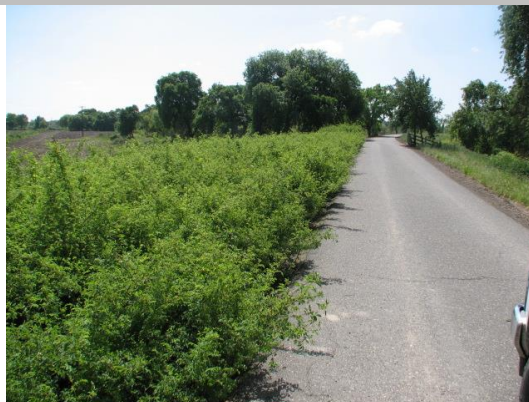
Photo 2 of 2 : SP_2017_RD2031_308_965_20170407_00010.jpg

Wild rose on levee slope.

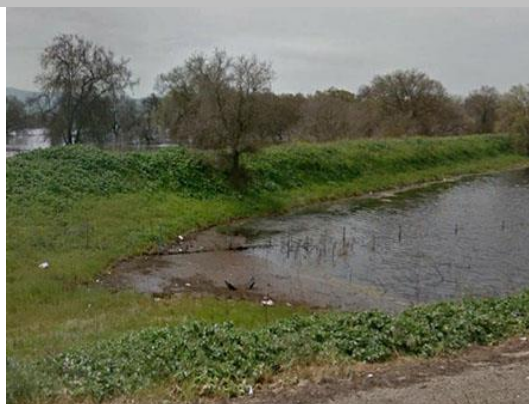
Photo 1 of 1 : SP_2017_RD2031_308_30_20170518_00054.jpg

View of the dense vegetation on the landside levee slope.

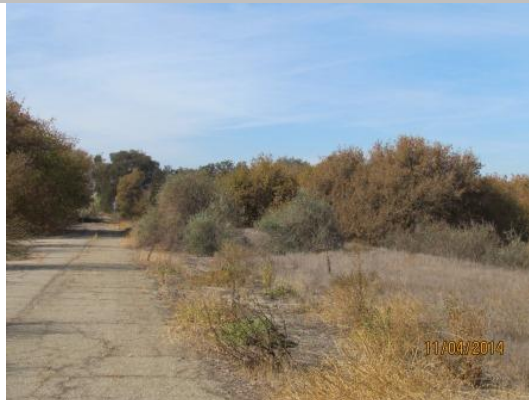
Photo 2 of 2 : SP_2017_RD2031_308_21_20170407_00006.jpg

Another view of overgrown vegetation on the levee crown.

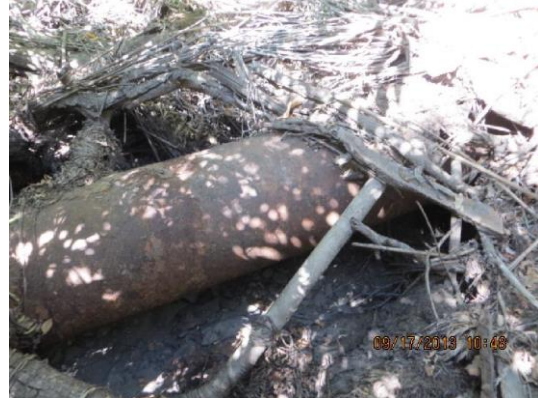
Photo 1 of 3 : UCIP_SP_2017_20713_34838.jpg

Pipe visible on LS toe.

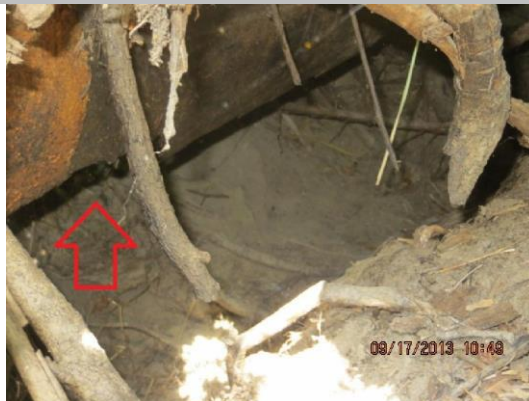
Photo 2 of 3 : UCIP_SP_2017_20713_34837.jpg

Flow line of pipe completely rusted through at LS toe.

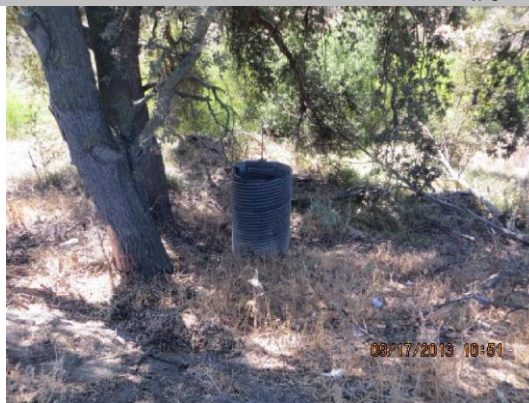
Photo 3 of 3 : UCIP_SP_2017_20713_34836.jpg

Slide gate in 48-inch CMP riser on WS slope.

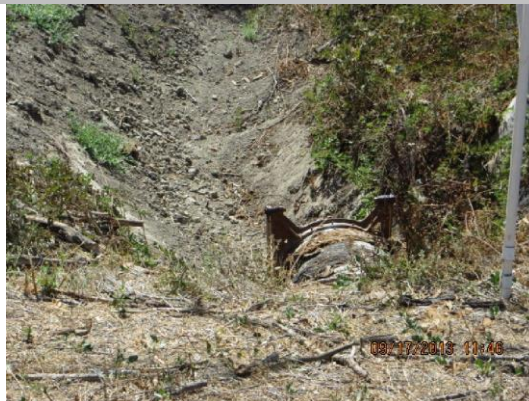
Photo 1 of 3 : UCIP_SP_2017_20723_34882.jpg

Flap gate on CMP pipe at WS toe.

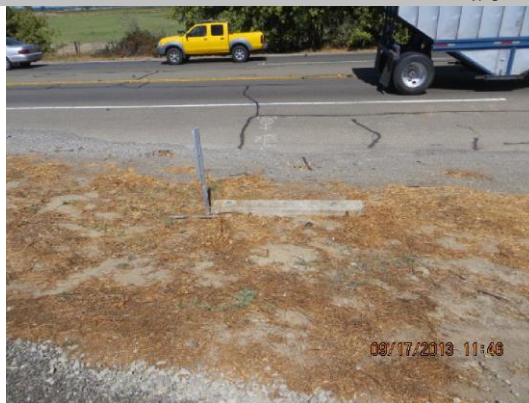
Photo 2 of 3 : UCIP_SP_2017_20723_34881.jpg

Concrete headwall on LS toe.

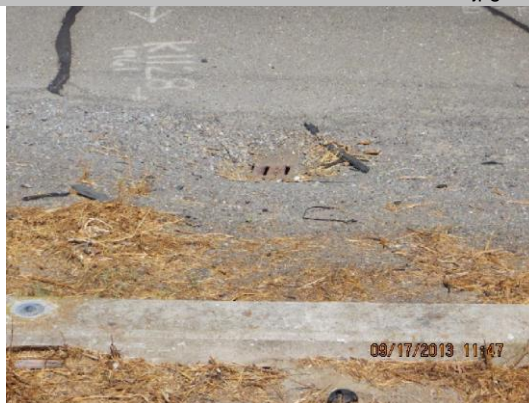
Photo 3 of 3 : UCIP_SP_2017_20723_34880.jpg

Drop inlet on LS toe.

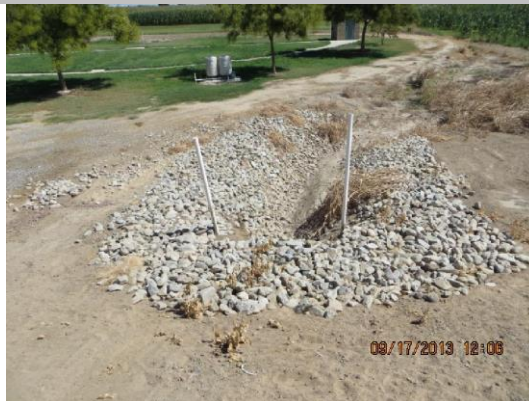
Photo 1 of 3 : UCIP_SP_2017_20728_34895.jpg

Concrete headwall at ditch on LS toe.

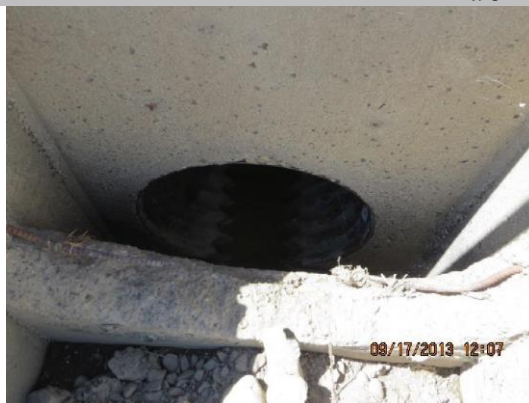
Photo 2 of 3 : UCIP_SP_2017_20728_34894.jpg

Concrete headwall on LS toe.

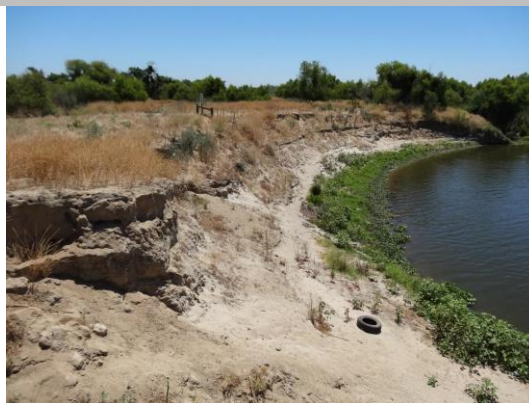
Photo 3 of 3 : SP_2017_RD2031_308_1_20170407_00003.jpg

Close view of the erosion.

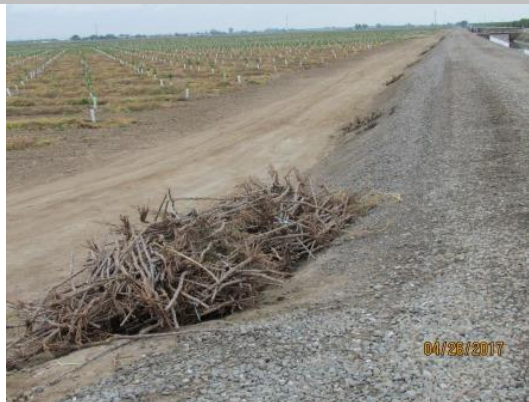
Photo 1 of 1 : SP_2017_RD2031_308_29_20170427_00053.jpg

View of the pruning pile on the levee slope.
